Apex Home Inspections LLC

## RESIDENTIAL INSPECTION REPORT

123 Sample Street, Demo City, ST 12345

6/21/2026 3:56PM

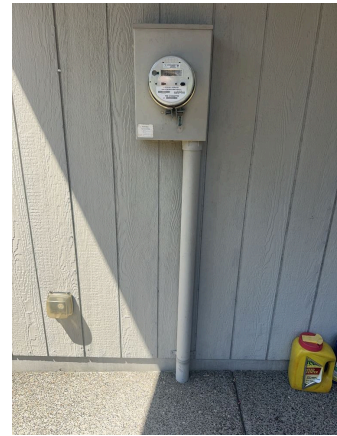
Below ground service lateral was observed. All visible/accessible equipment was inspected, no reportable defects or deficiencies were observed and the main panel and service conductors were deemed to be satisfactory unless otherwise noted in this report.

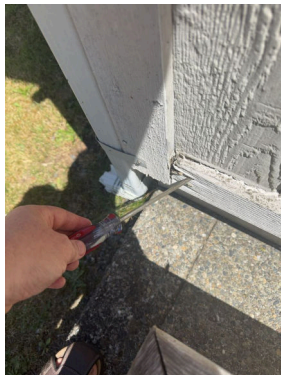
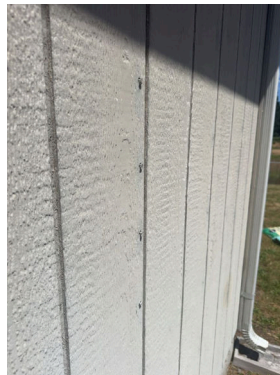
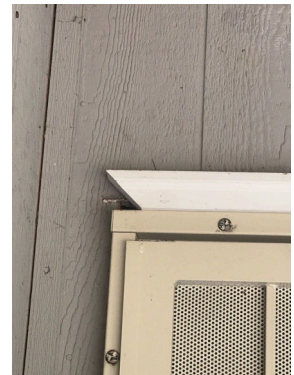
#### 2.4.2 Siding Generally Satisfactory - Some Repair Recommended

The siding overall was observed to be in generally satisfactory condition with some areas in need of minor repair and maintenance.

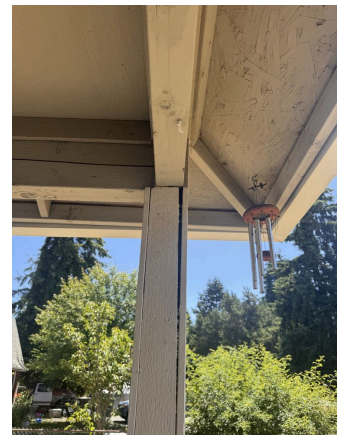
Gaps, cracks, holes or openings were observed in the siding, trim and/or exterior cladding. These areas represent a moisture and pest intrusion risk and can lead to water damage of the interior walls or structure. I recommend repair by a qualified handyman or siding contractor.

Trim covering framing is loose.

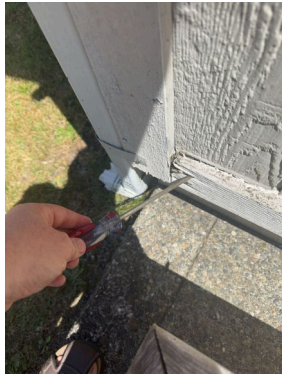
Numerous areas of the exterior trim was observed to have areas that were rotted and or deteriorated. This can be a water and pest intrusion risk and can lead to further damage to the home. I recommend repair by a qualified siding contractor.

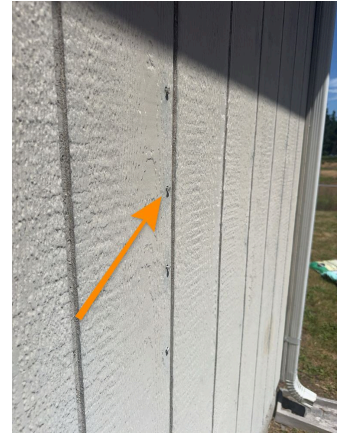
One or more areas of the siding was observed to have a screw or nail protruding. This can be a moisture intrusion risk and can lead to water damage. I recommend repair by a qualified contractor.

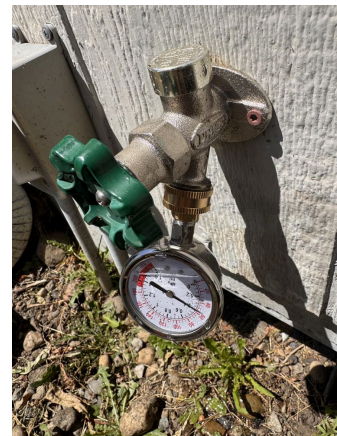
#### 2.8.1 Exterior Hose Bibs: Satisfactory Water Pressure, Satisfactory

55 psi

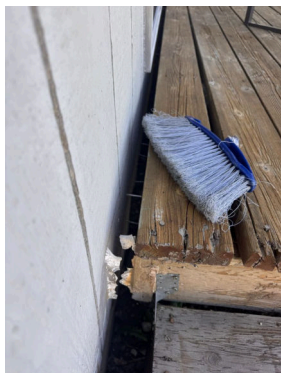
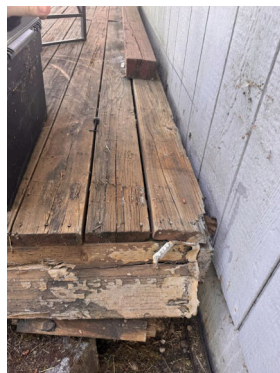
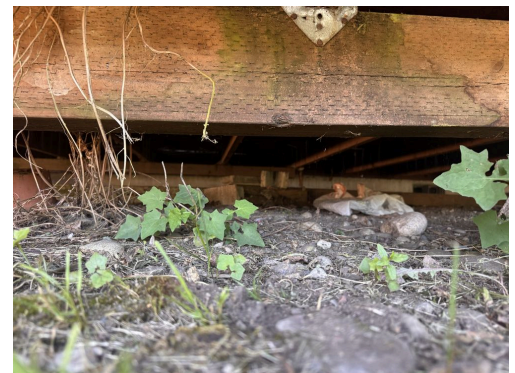
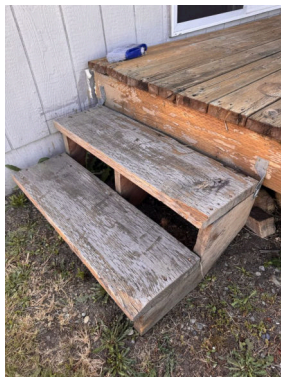
#### 2.9.1 Type of Structure: Rear Deck

### 2.9.2 Deck Overall - Unsatisfactory

Overall the deck was observed to be of improper, inadequate, non-typical and/or non-professional construction, and does not meet modern deck construction standards.

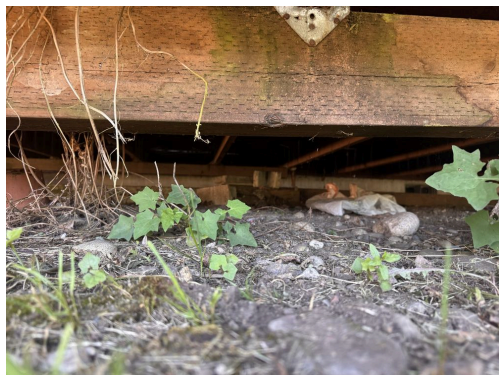
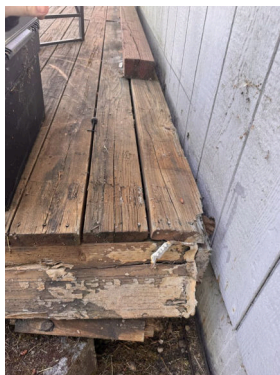
Improper attachment

The deck was observed to be in generally poor/unsatisfactory condition. The deck is sagging slightly in the center, the wood is weathered, there are deck planks loose and not secured—some that are unsafe near the edges. Some of the support posts do not appear to have load transfer to the ground.

It is recommended that the deck and roof structure over it be fully evaluated, repaired or replaced as deemed necessary by a qualified carpenter or deck contractor.

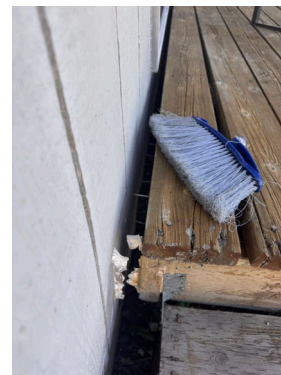
Deck improperly attached to house.

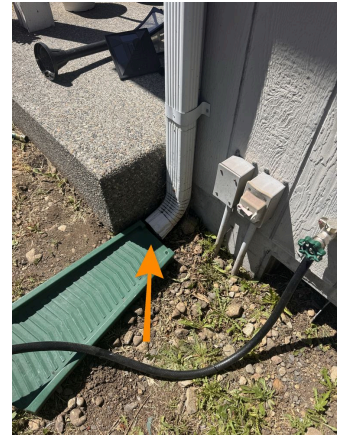
One or more downspouts drain too close to the home's foundation. This can result in excessive moisture in the soil at the foundation, which can lead to foundation/structural movement, foundation cracks, and other defects. Excessive moisture levels in soil near the foundation can effect the ability of the soil to support the weight of the structure above and can cause damage related to soil/foundation movement. Water should always be directed 6-10 feet away from the foundation.

The Inspector recommends the installation of downspout extensions to discharge roof drainage a minimum of 6 feet from the foundation by a qualified gutter contractor or handyman.

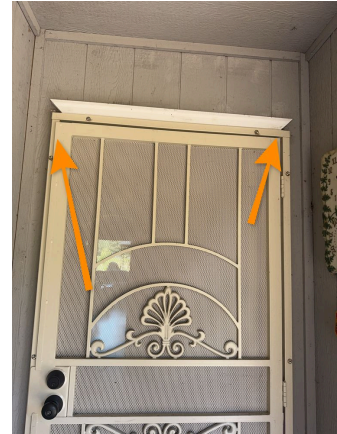
Gaps, Openings or Holes were observed at one of the exterior doors or door frames. The siding did not adequately abut the frame and it is a water intrusion concern. I recommend caulking or sealing the gaps.

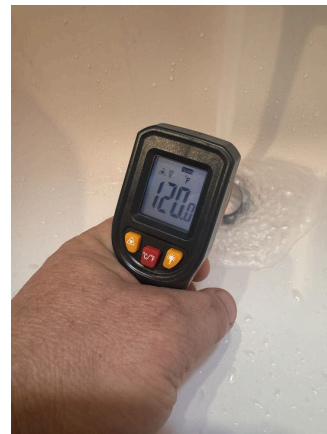
#### 3.8.1 Water Temperature: Satisfactory

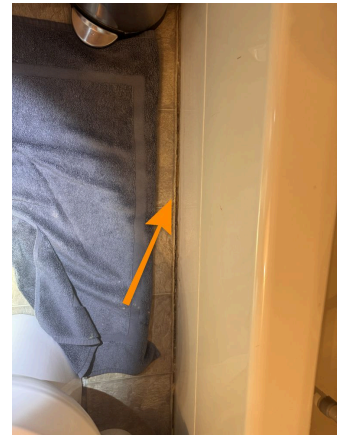
Bathtub, shower or other areas of the bathroom was observed to have poor caulking. Some gaps that are moisture intrusion risks were not properly caulked.

Recommend cleaning and caulking bathtub where it meets the floor, and sealing any gaps to prevent moisture intrusion into the walls or floors by a qualified handyman.

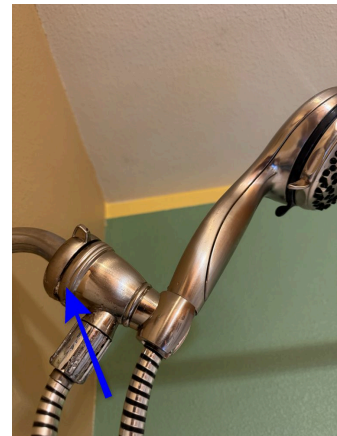
Showerhead is leaking and can result in a water damage. Recommend replacement by a handyman or plumber.

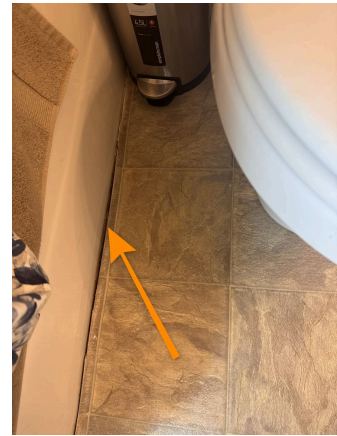
Bathtub, shower or other areas of the bathroom was observed to have poor caulking. Some gaps that are moisture intrusion risks were not properly caulked.

Recommend cleaning and caulking bathtub where it meets the floor, and sealing any gaps to prevent moisture intrusion into the walls or floors by a qualified handyman.

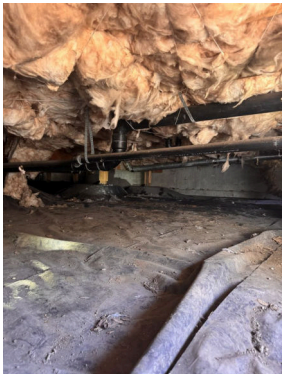
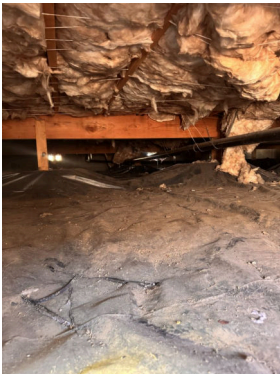
9.1.4 Interior Foundation

Interior foundation was inspected by looking for damage, cracks, bowing, leaning, displacement, etc. No reportable deficiencies were present at the visible portions of the foundation at the time of inspection unless otherwise noted in this report. Overall the foundation was observed to be in satisfactory condition.

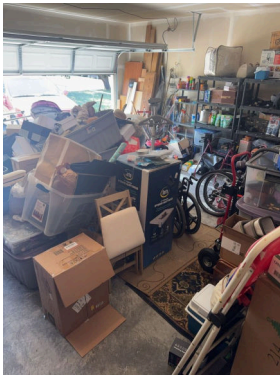
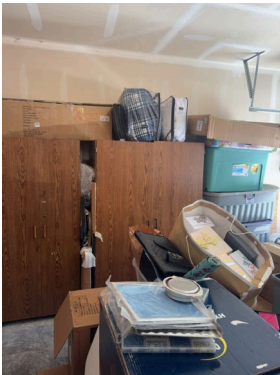
11.1.1 Personal Items - Impeded Visual Accessibility

The garage had a heavy amount of personal items present that prevented visual inspection of all areas.

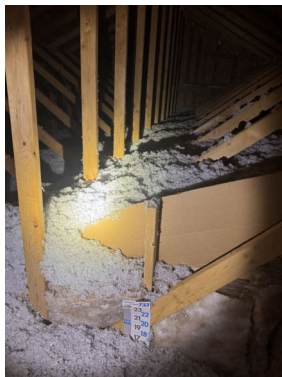
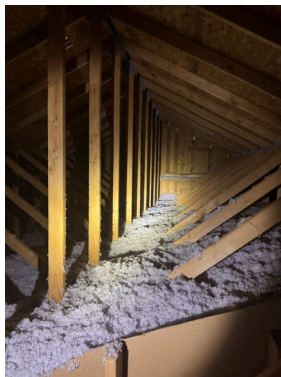
13.2.3 Attic Not 100% Accessible or Visible

Not all areas of the attic were readily accessible. Inspection included all areas that were readily accessible.

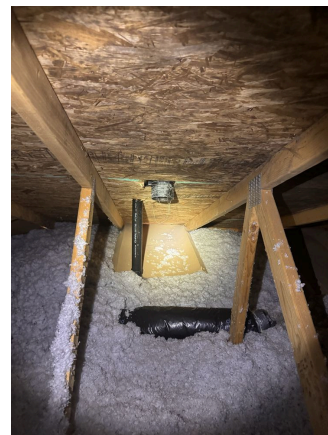
Hallway bathroom duct

The hallway bathroom vent was observed terminating into the attic. This is a defect that should be taken seriously as it can cause significant moisture damage and mold growth. Recommend a qualified attic contractor properly terminate all bathroom vents to the exterior.

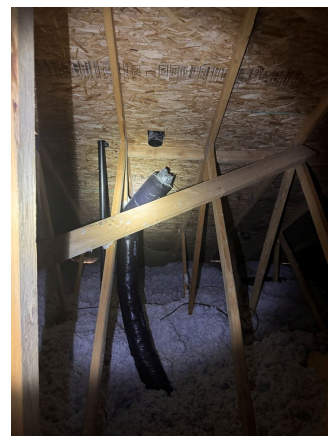
Laundry room duct

HVAC ductwork was observed to be loose or disconnected. This can lead to moisture or pest intrusion into the ducts, and can lead to damage. I recommend repair by a qualified HVAC contractor.

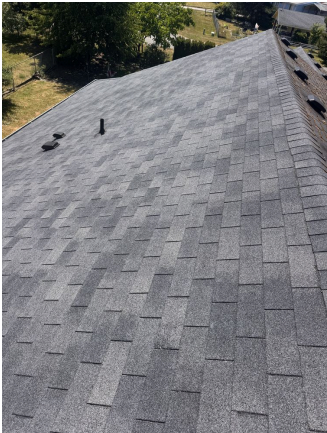
#### 14.2.1 Roof Covering

The roof covering was inspected for visible defects such as discoloration, curling, lifting, buckling, de-lamination, granule loss, damage, missing shingles, exposed nail heads, rusted nail heads, improper installation, overexposed shingles, etc.

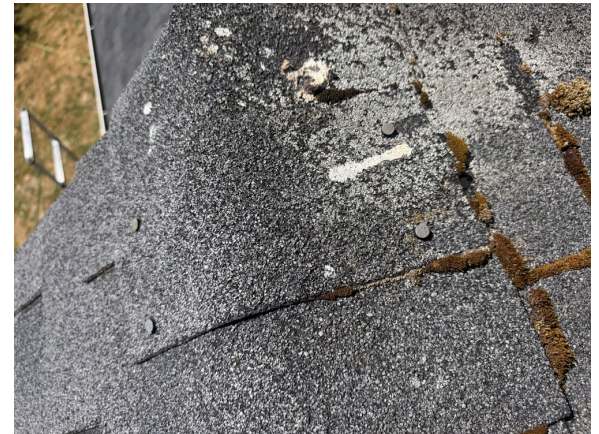
Exposed nail heads were observed on the roof covering, ridge areas and roof penetration flashings. Exposed nails can rust. As the nail rusts, its diameter shrinks but the original hole stays the same size.

I recommend evaluation of the roof covering and repairs made as deemed necessary by a qualified roofing contractor.
